Manhole Inspection Summary

Manhole # S39C__033MH

Insp Date: **11/5/08 2:35 PM**

Location Address: **1099 orleans st**

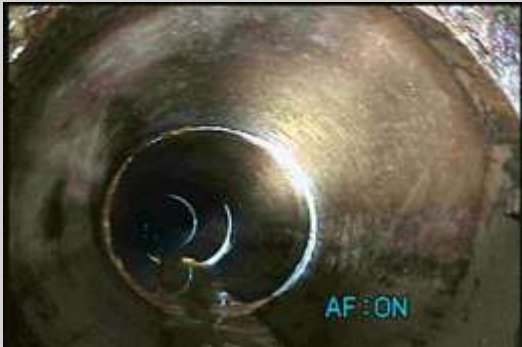
12 O'Clock Outflow

10 in. Circular Gravity Sewer
Pipe Out @ 12 O'Clock

Invert Depth: 14.50 (ft.) Flow Characteristics: Slow

Infiltration: None Pipe Seal Cond: Unknown

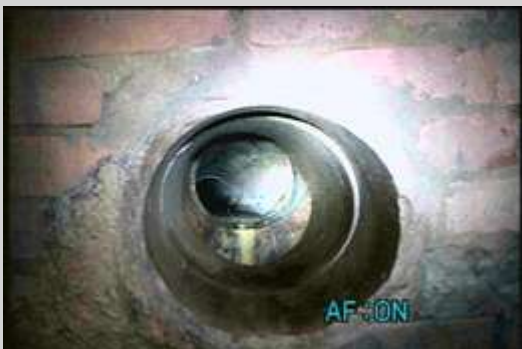
6 O'Clock Inflow

8 in. Circular Gravity Sewer
Pipe In @ 6 O'Clock

Invert Depth: 12.10 (ft.) Flow Characteristics: None

Infiltration: None Pipe Seal Cond: Unknown

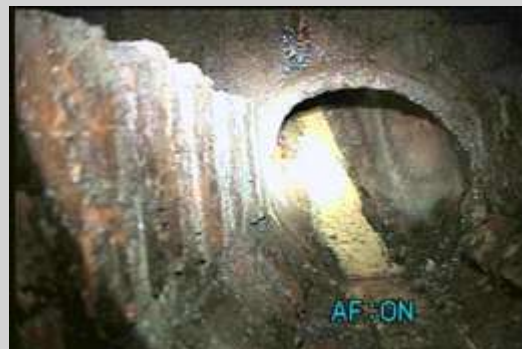
Drop In @ 6 O'Clock

Drop: Outside Direct

Drop Condition: Open

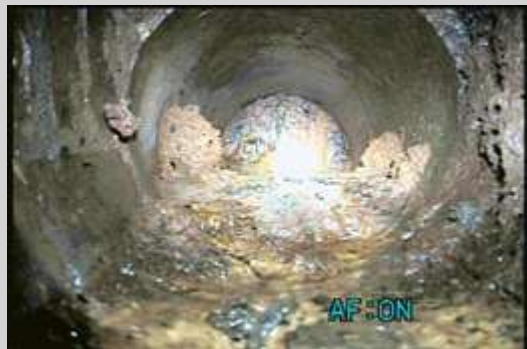
9 O'Clock Inflow

8 in. Circular Gravity Sewer
Pipe In @ 9 OClock

Infiltration: None
